Application: Corrugated Container Plant - Folder-Gluer

Process description:

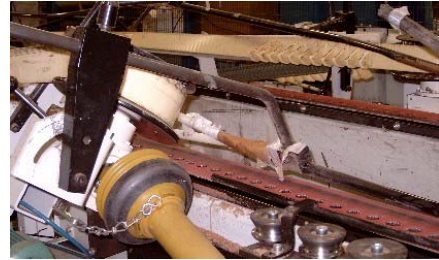
Not operating

After leaving the dye cutter the board enters a folder gluer. In the folder-gluer the board is transported on two conveyor belts. The lower folding belts (pink) are next to each other with approximately a 25" (635mm) space in between. In order to prevent the corrugated board from sliding out of position, the two lower belts are under constant vacuum.

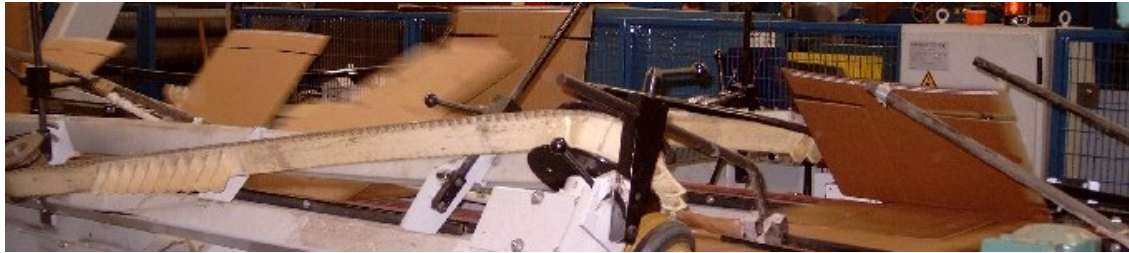
Operating

First glue is added on the board. Then the parts of the board that have to be folded to the middle, hit folding rails. These rails, together with a second pair of conveyor belts (the upper folding belts) are running in conjunction to perform the folding process. This second pair of belts has soft pieces of rubber attached to them that act like fingers when folding the boxes. At the end a wheel is rolling between the two conveyors, this wheel presses the glue to the board.
